# **Reconnaissance of Damage Due to Hurricanes Katrina and Rita**

**Physical Security & Systems  
Interagency Working Group  
March 24, 2006**

**Stephen A. Cauffman  
Leader, Structures Group  
Building and Fire Research Laboratory  
National Institute of Standards and Technology  
cauffman@nist.gov**

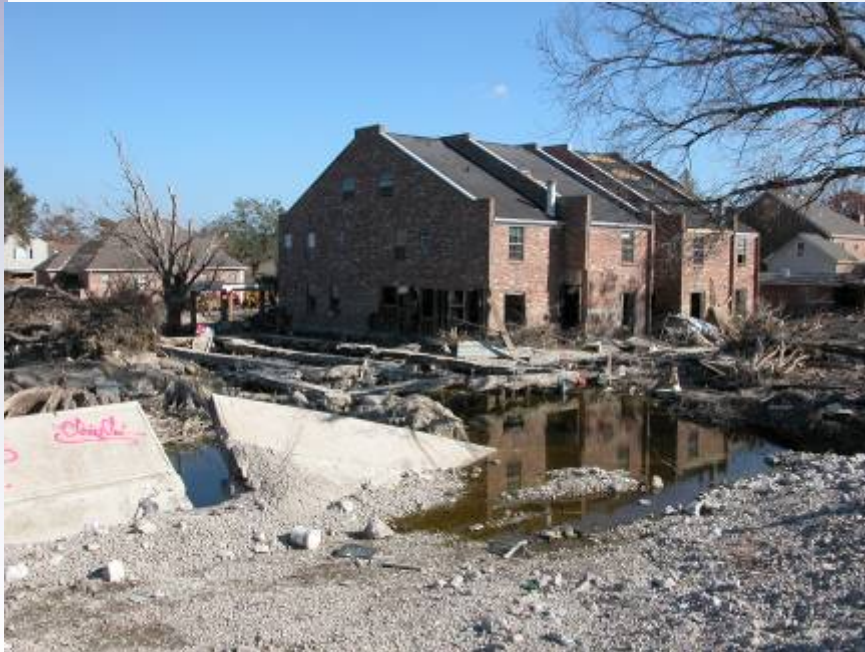
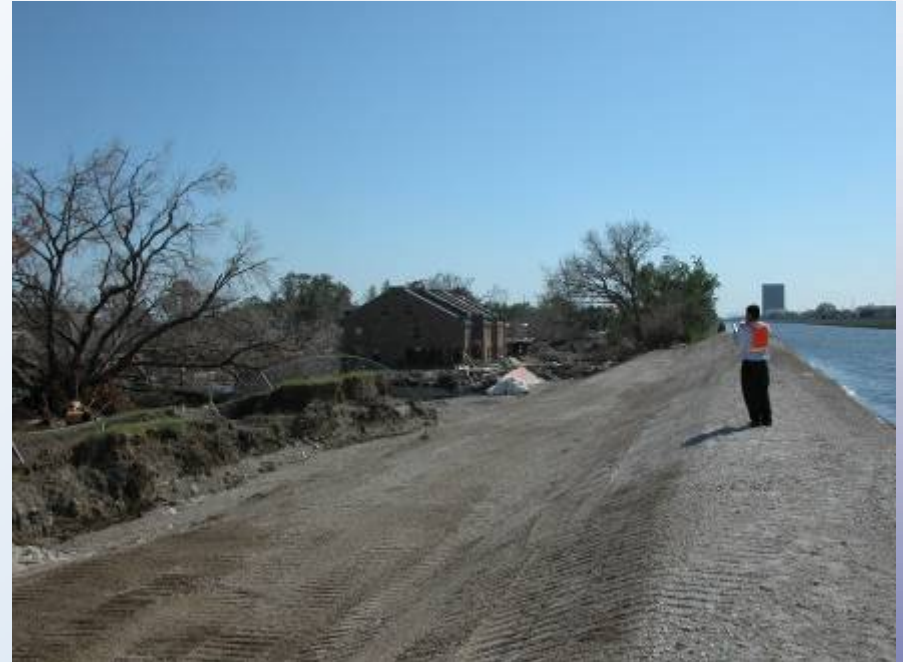
## 17<sup>th</sup> St Canal Outfall Canal

- Sliding failure of floodwall
- Failure is believed to be due to loss of soil strength resulting from saturation (seepage under sheetpile).
- Overtopping was not believed to occur at this location.

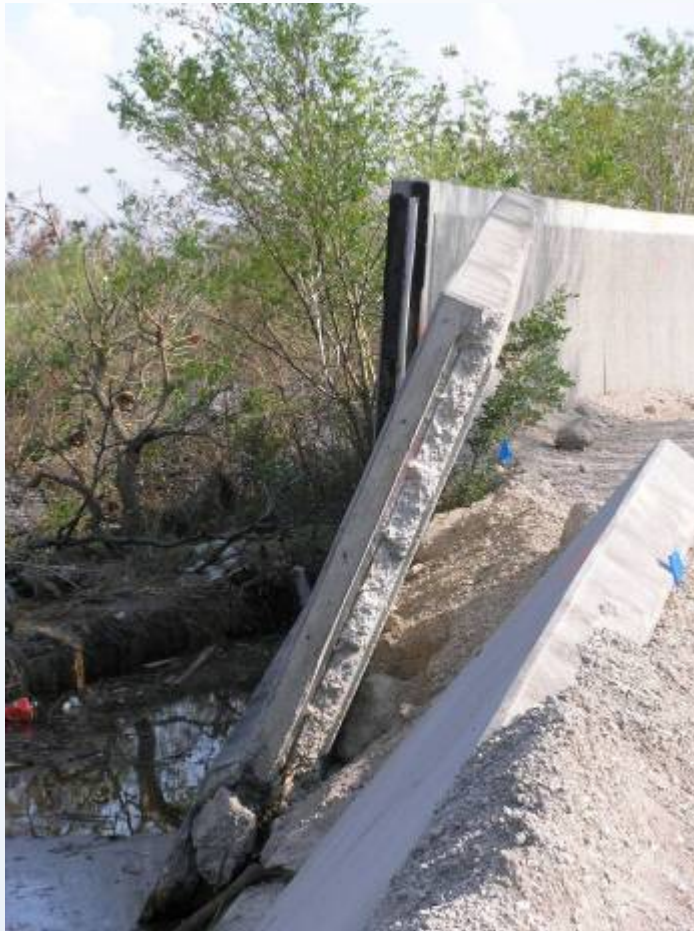
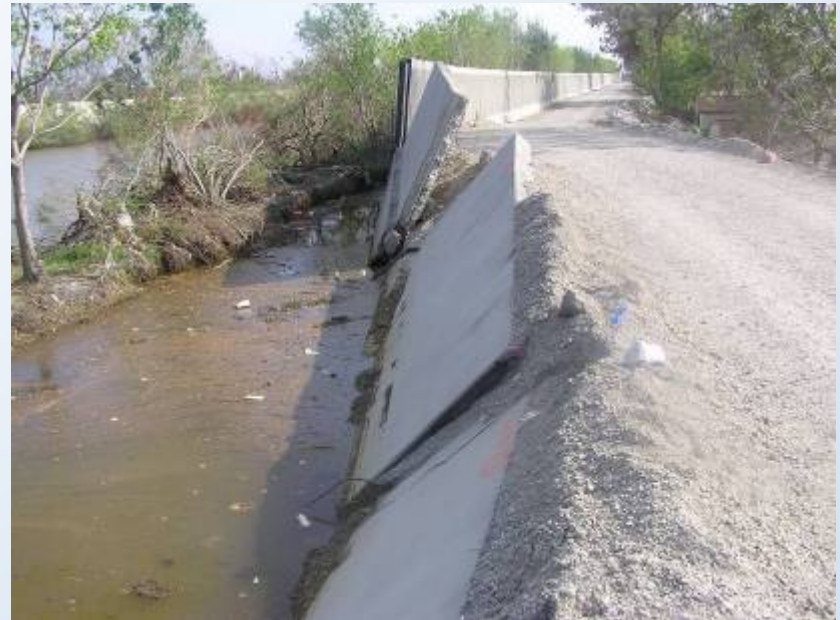
# London Ave Canal Levee Breach

- Lateral displacement of floodwall due to loss of soil strength on protected side.
- Saturation of soil due to seepage beneath sheetpile.
- Overtopping not believed to have occurred at this location.

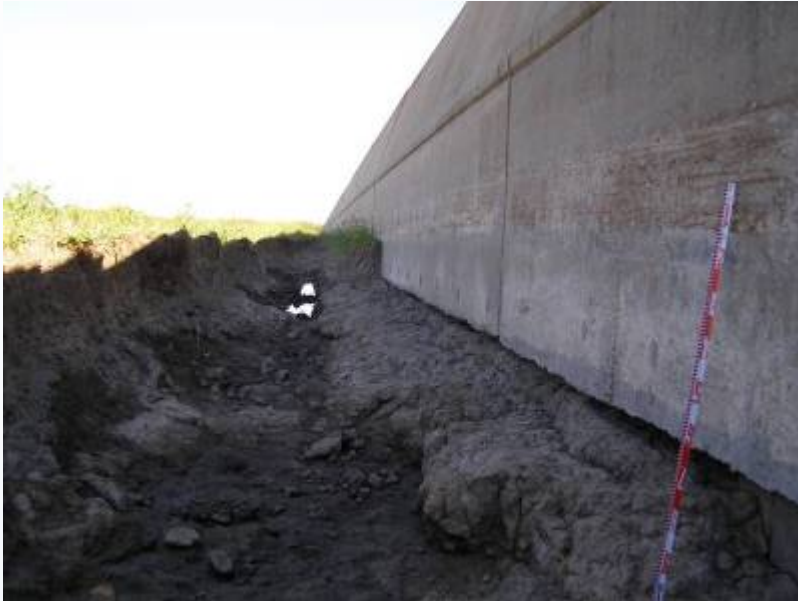
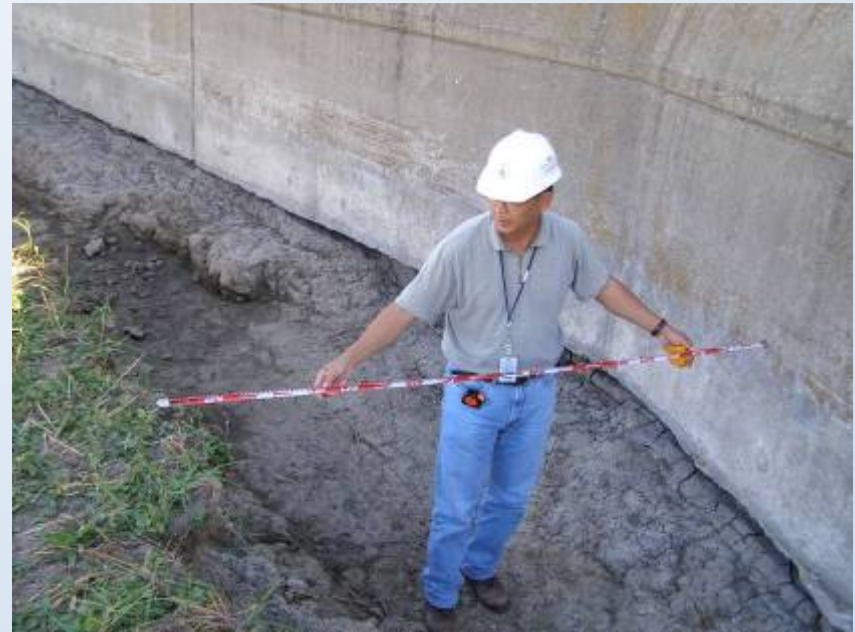
# Scour Behind Levee at Entergy Michaud Power Plant

- Evidence of overtopping at this location.
- Scour on protected side of levee due to overtopping.
- Floodwall remained in place.

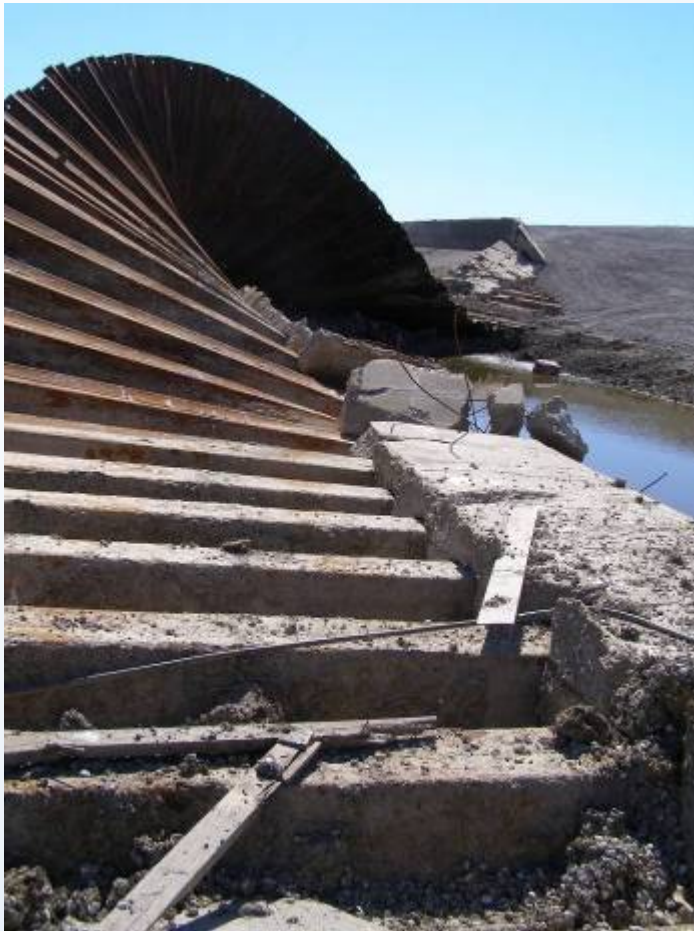
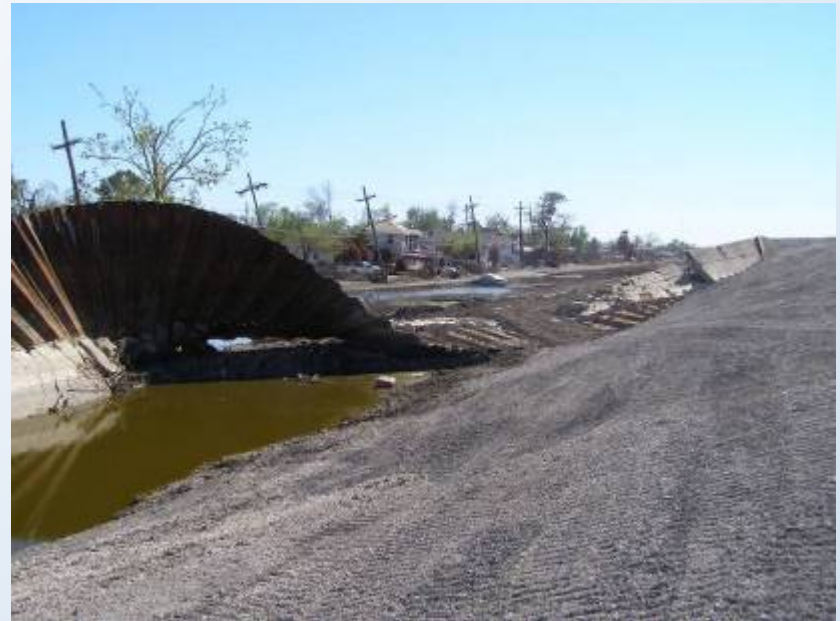
## Inner Harbor Navigation Canal (Lower Ninth Ward)

- Overturning failure of floodwall due to overtopping and scour on protected side of levee.

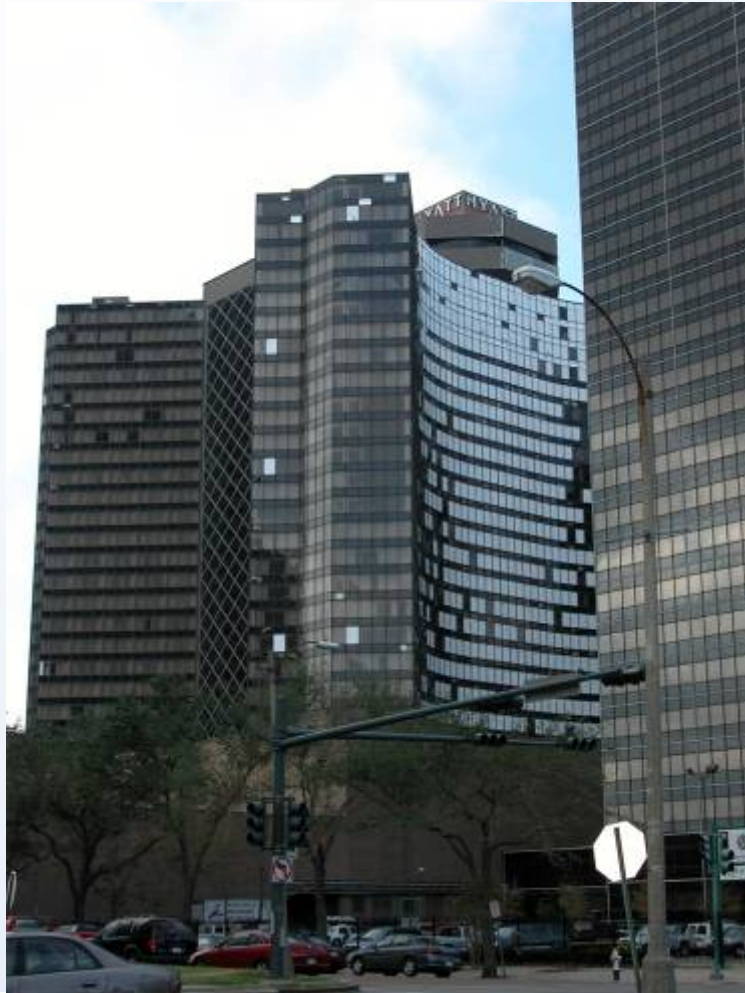
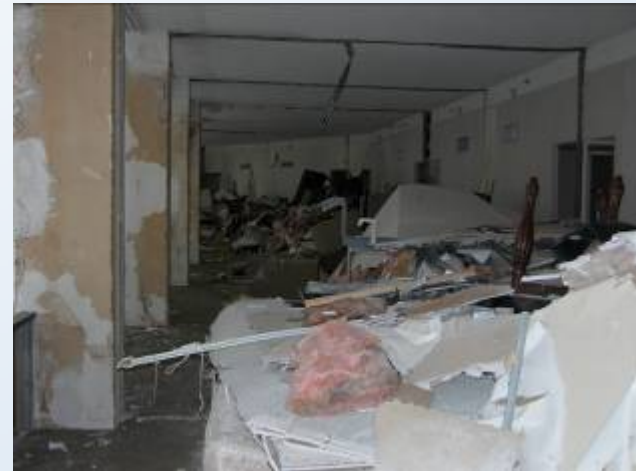
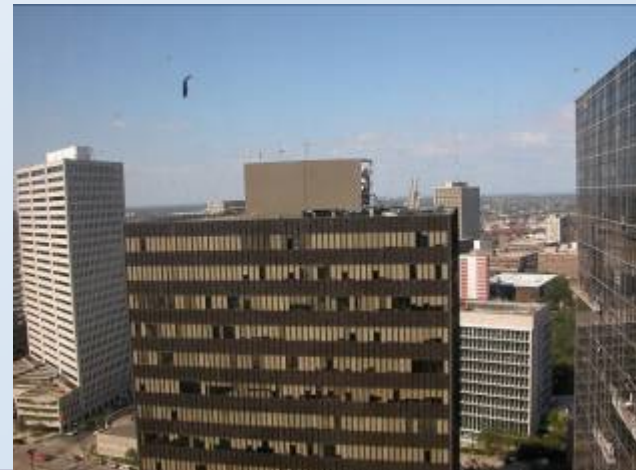
# Window Breakage from Windborne Debris

- Aggregate surface roofs on adjacent buildings were sources of wind borne debris.

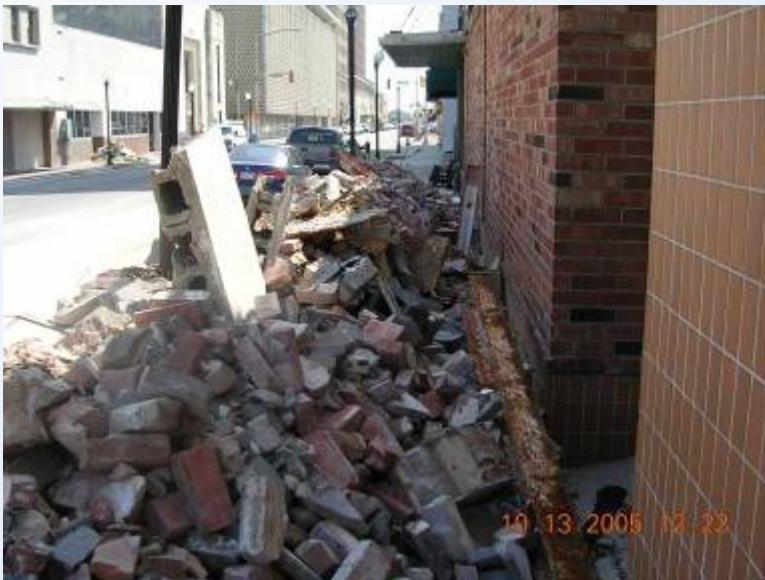
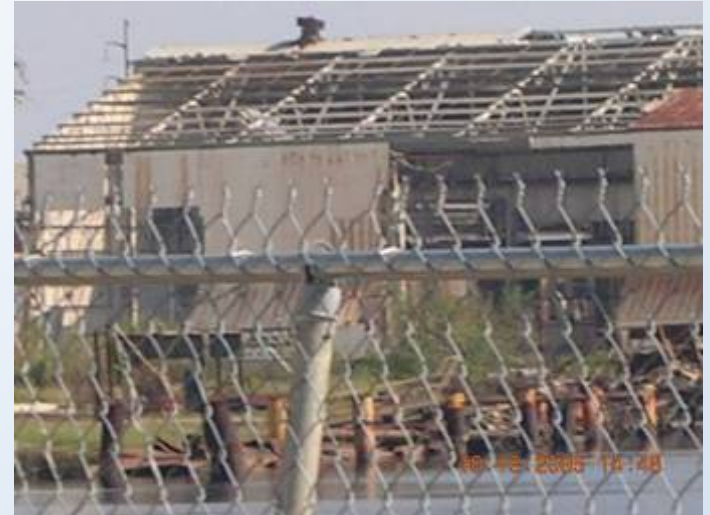
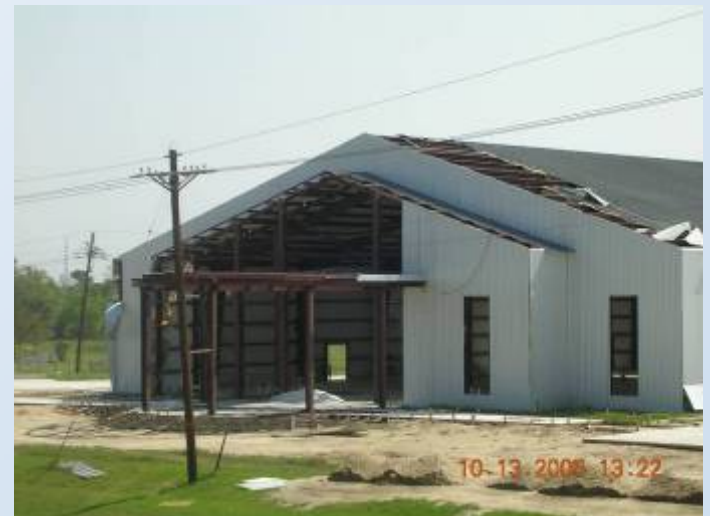
# Building Envelope Failures Due to Wind

- Metal roof and wall cladding
- Brick veneer

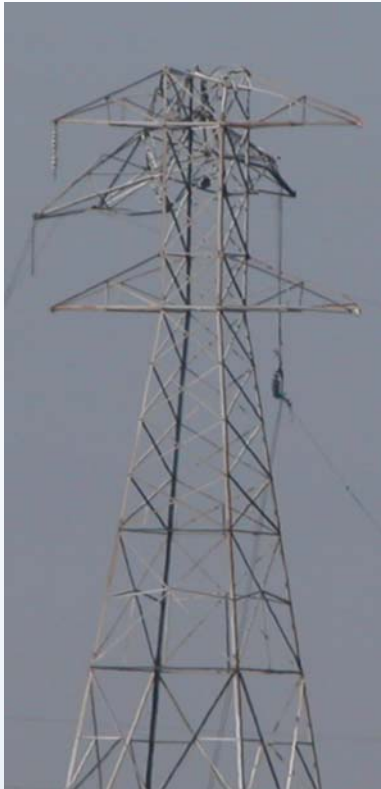
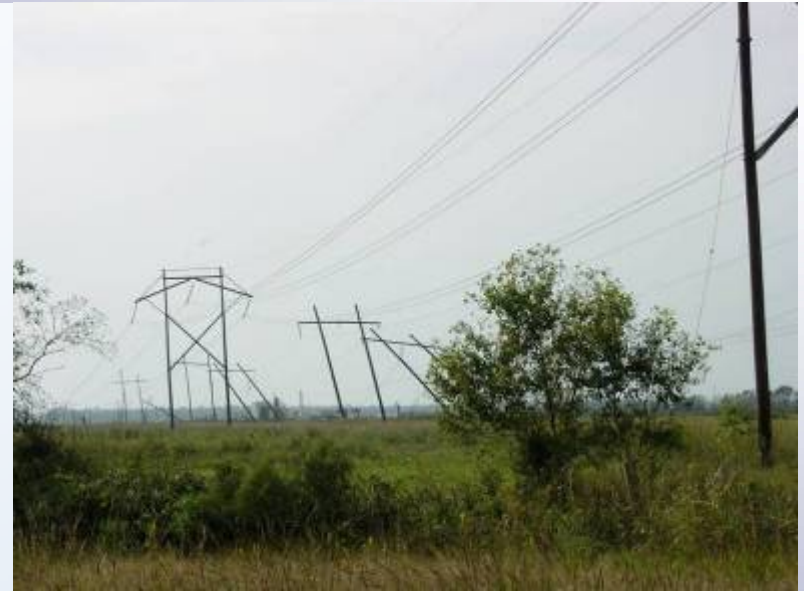
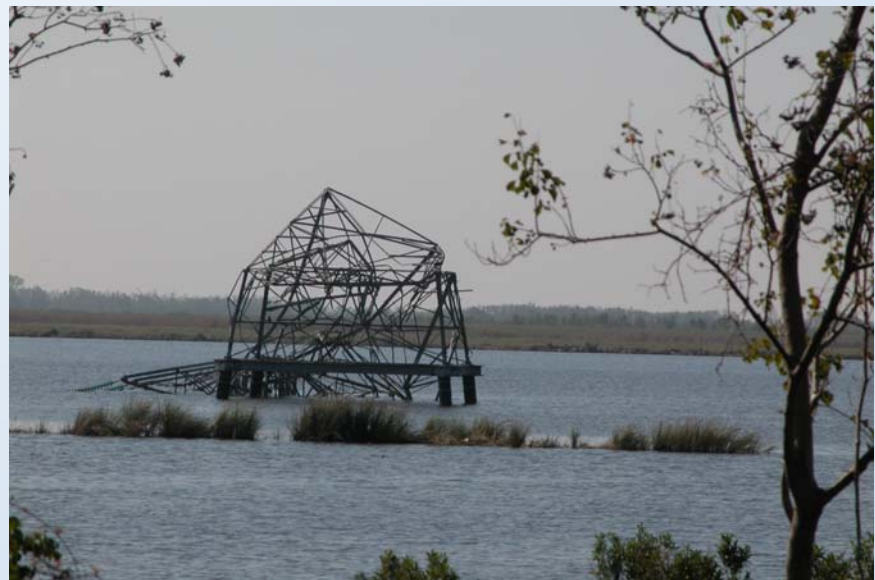
# Transmission Towers

- ~150 towers, steel poles lost
- Many cascade failures
- Failures caused by wind

230kV line over Highway 73

138kV line over I-10

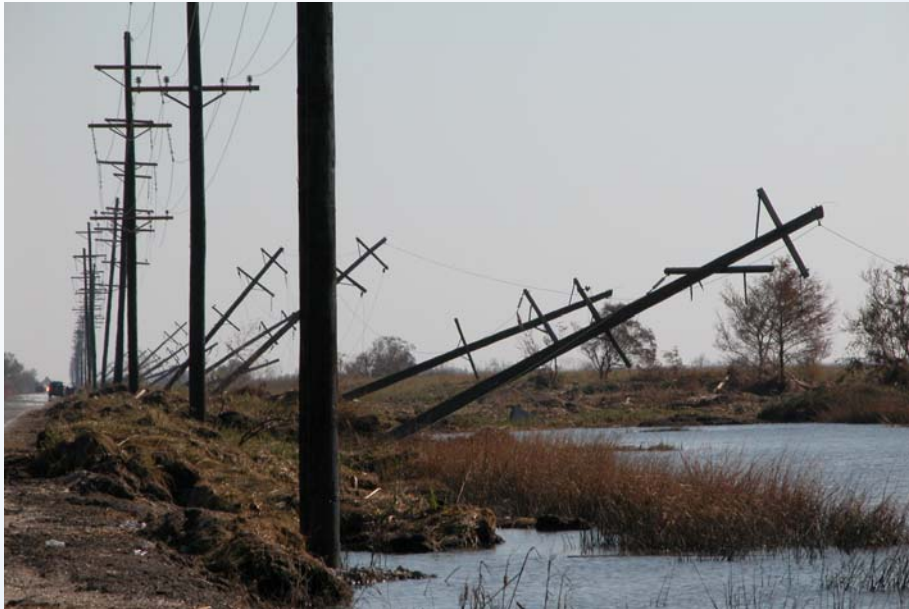
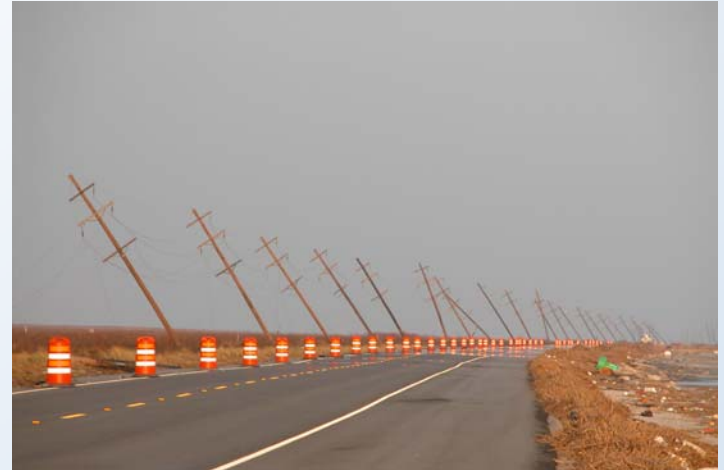
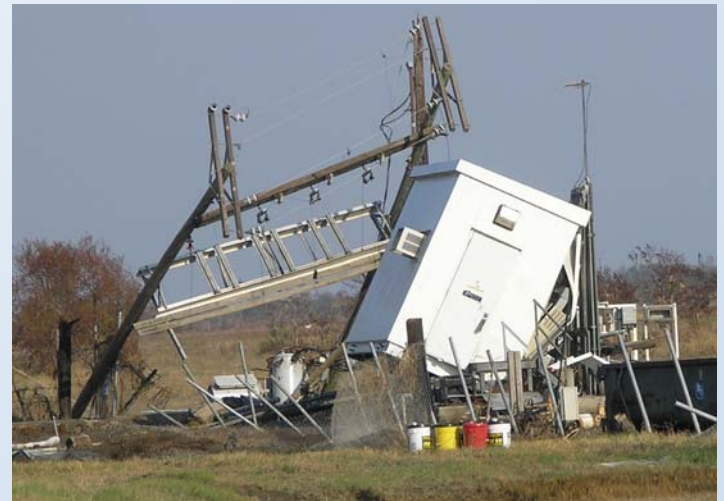
# Distribution Poles

~600,000 poles lost due to wind

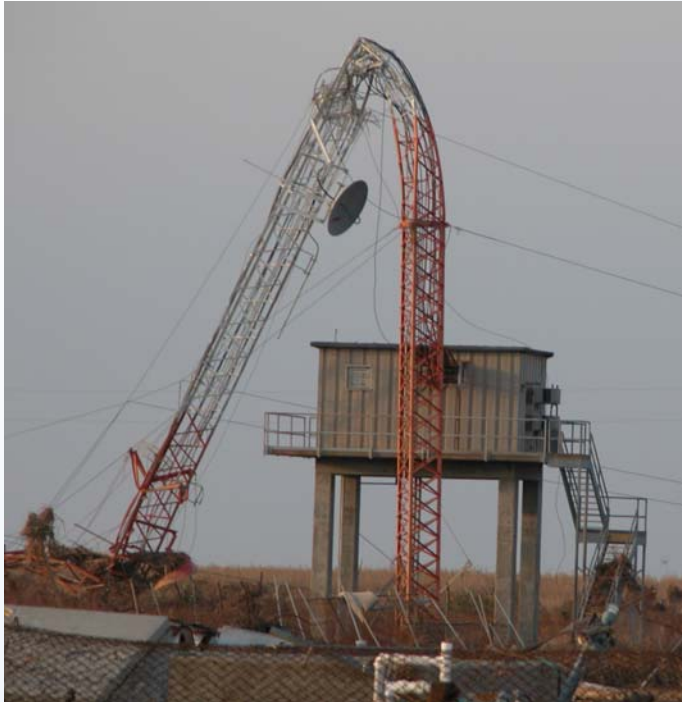
Cell tower failure, Route 82, coastal LA

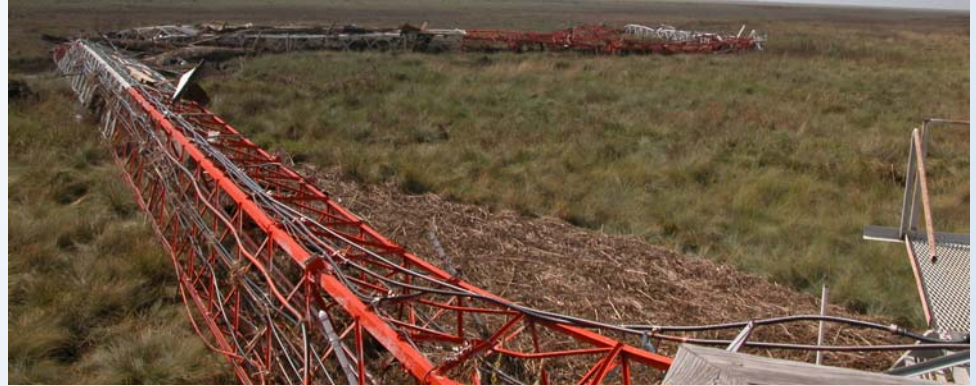
Sabine Pass tower failure

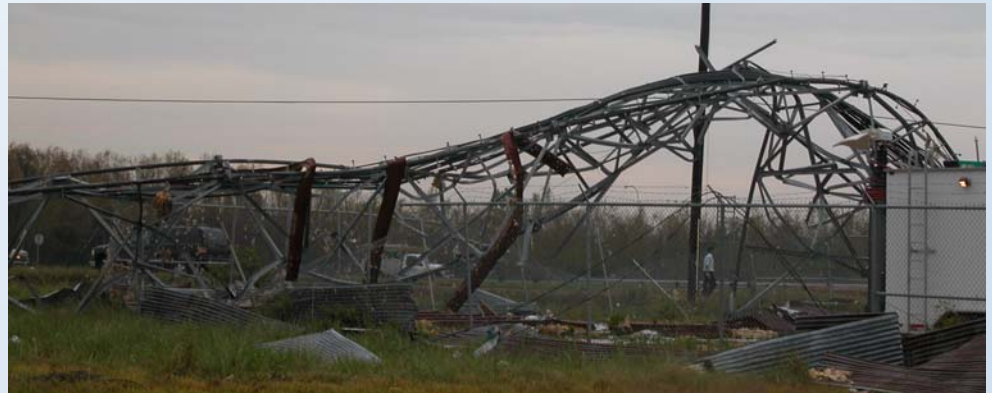
Orange cell tower failure

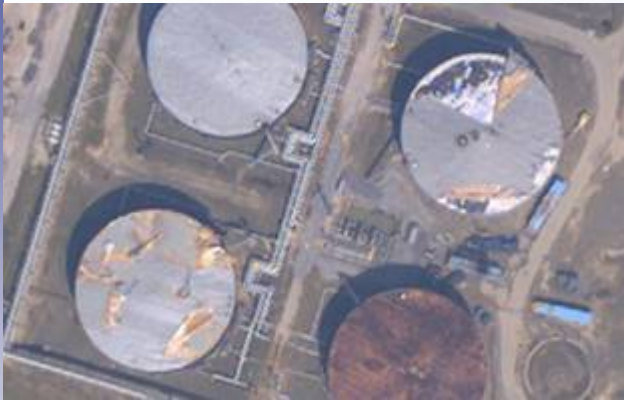
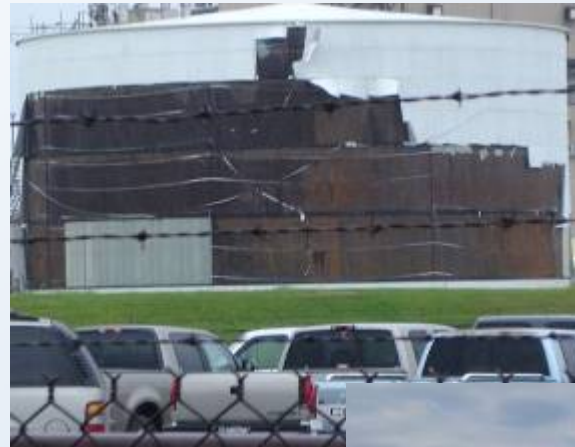
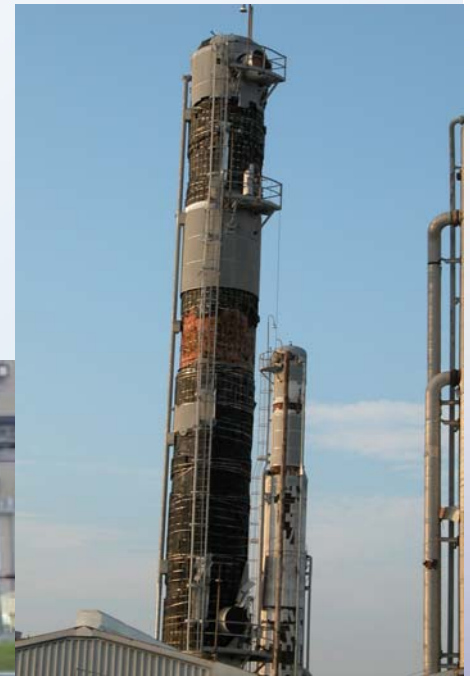
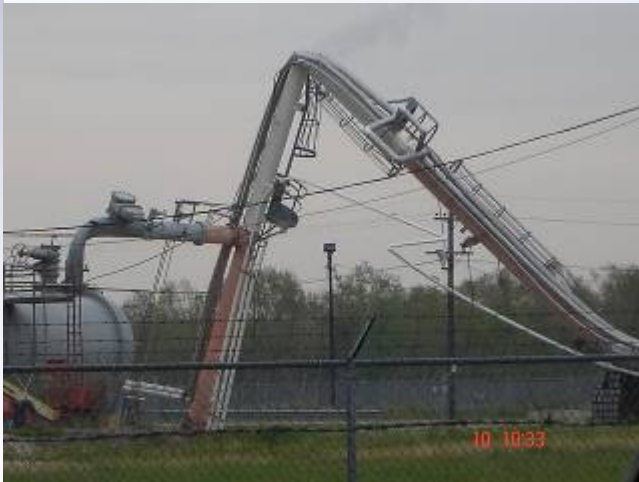
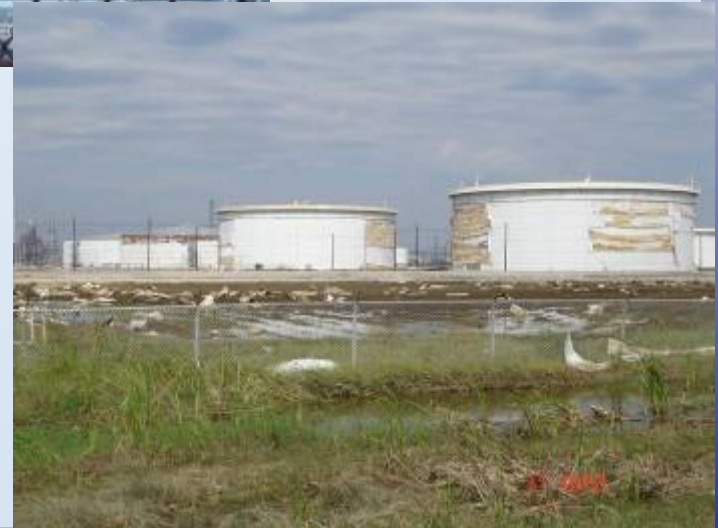
# Oil Refineries & Chemical Plants

Cladding damage to towers and tanks due to wind.

Flare tower failure, Orange

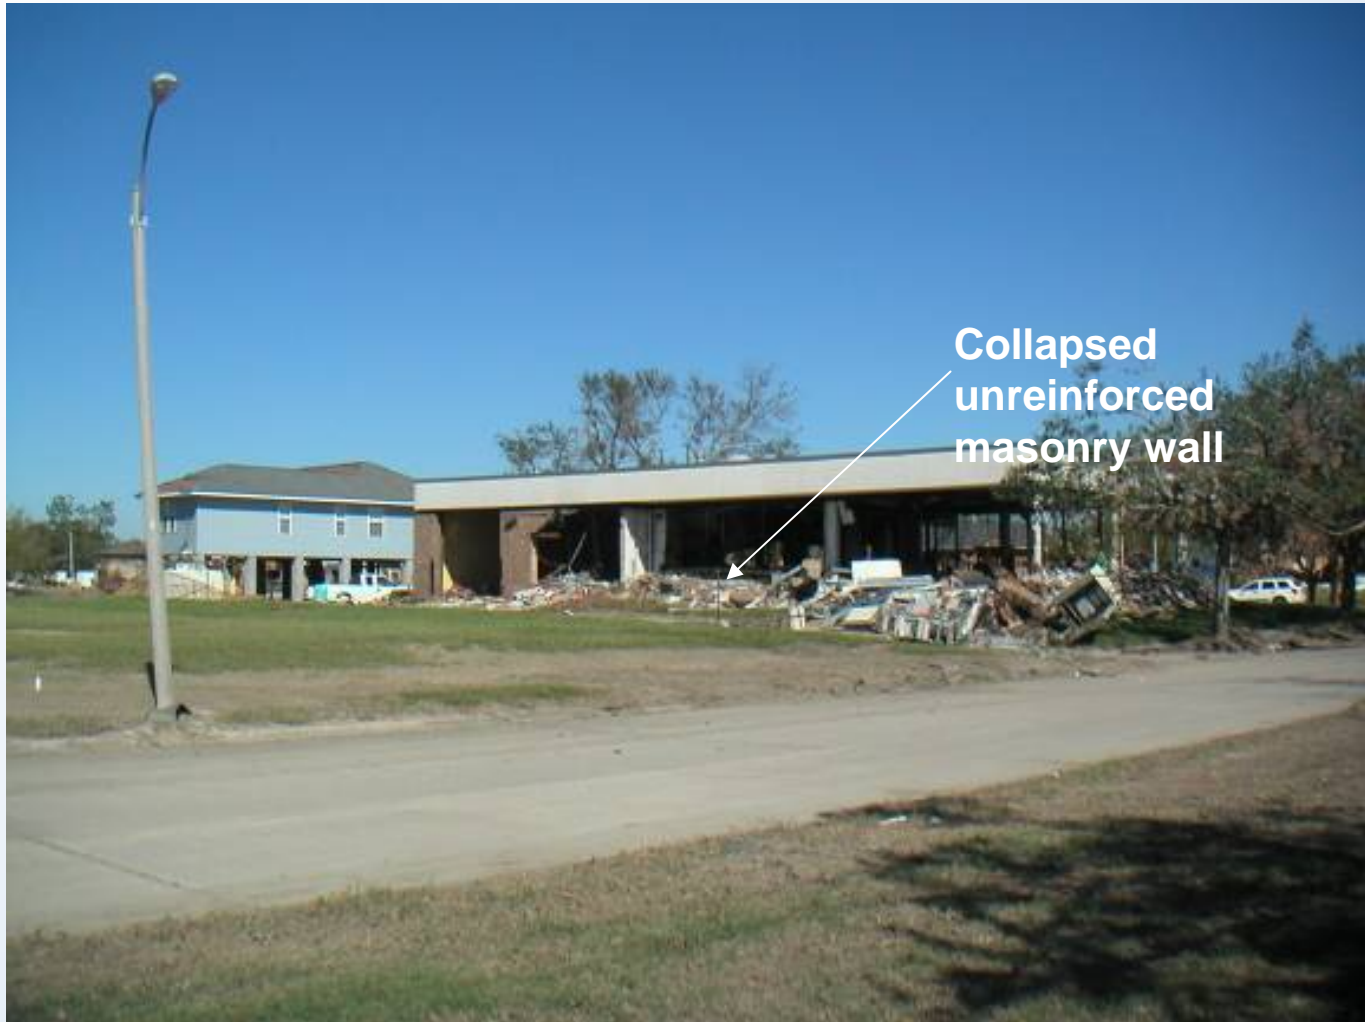
Venetian Isles fire station

## URM Wall Collapse in Area Exposed to Water Pressure

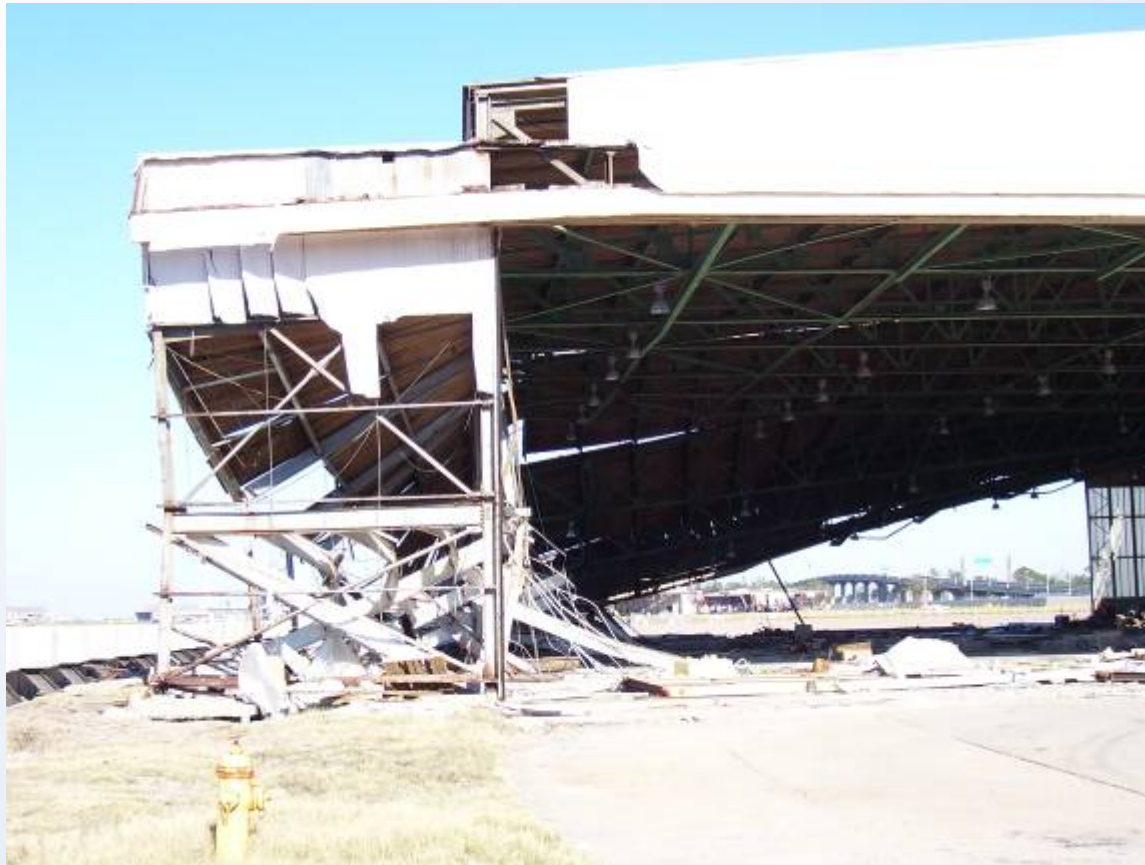
# Reinforced Masonry Wall Damage Due to Water Velocity

Grouted, reinforced masonry wall 20 ft from seawall.  
Short lap splice observed at fracture, consequent frame collapse

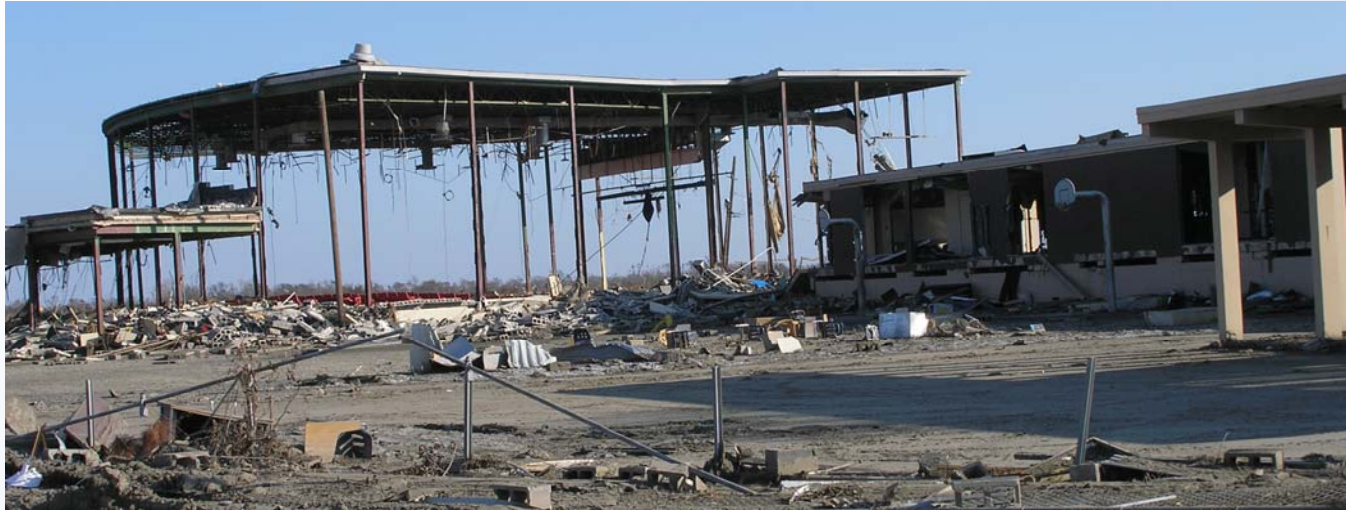
**Damaged school recreational facility, Cameron**

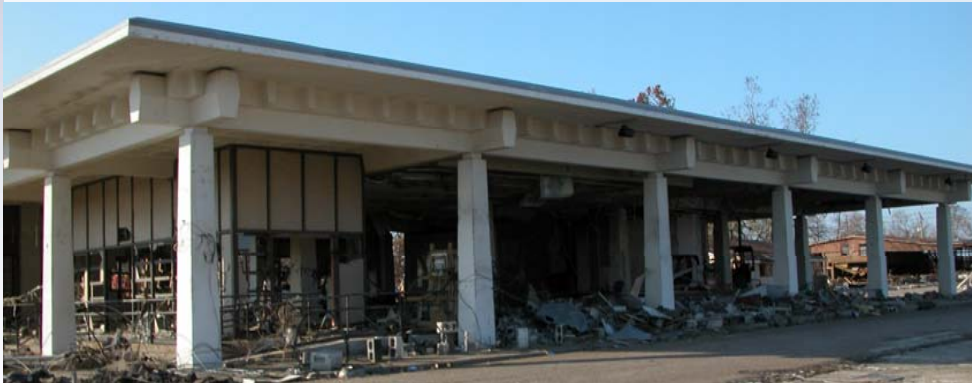
**Hibernia Bank building, Cameron**

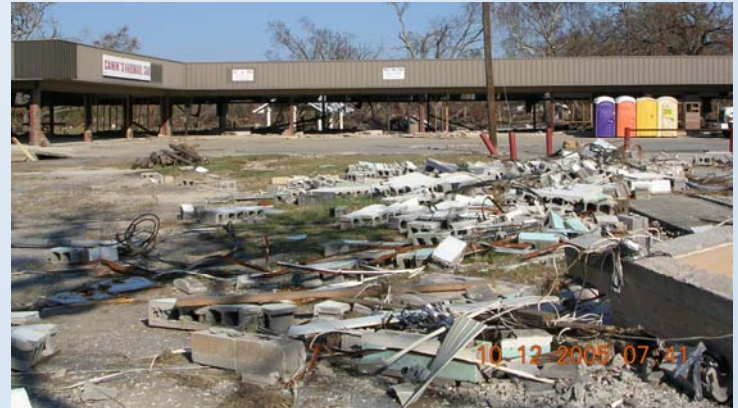
**Damaged strip mall, Creole**

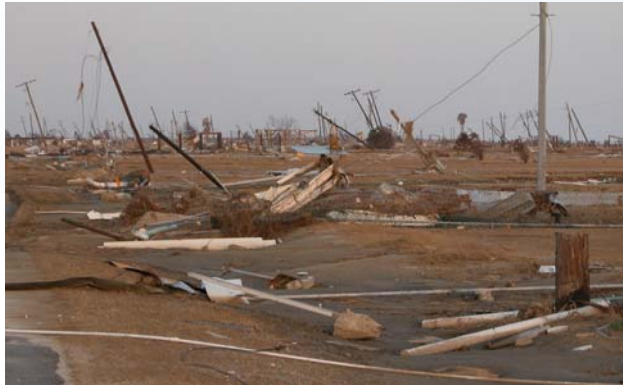
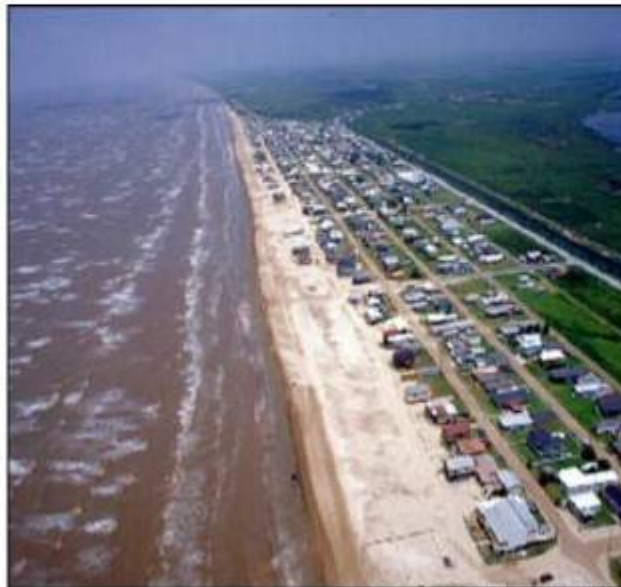
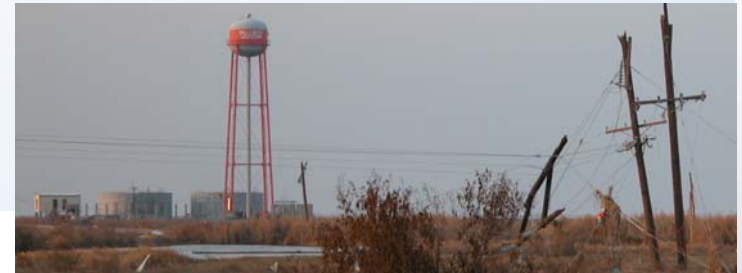
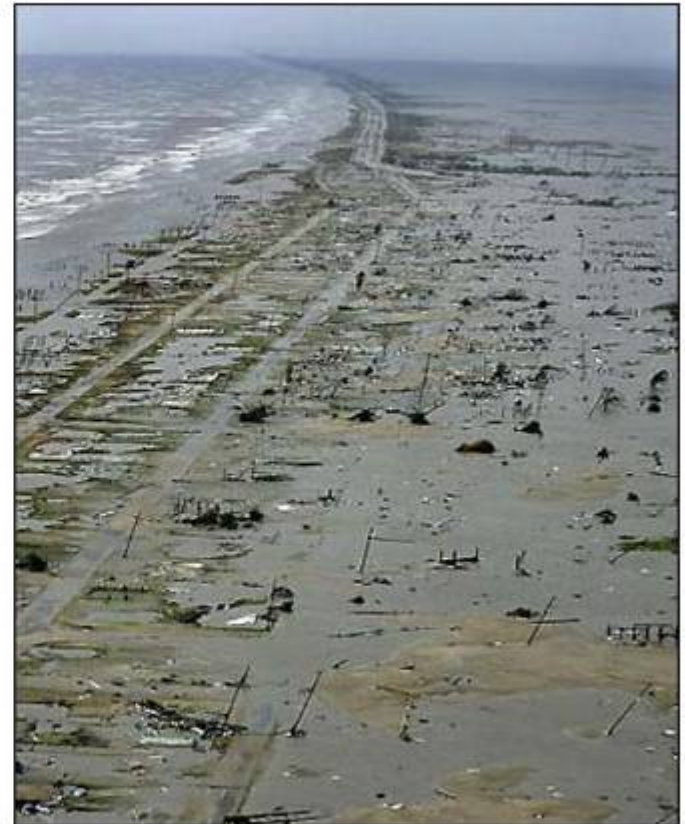
# Storm Surge Damage, Holly Beach, LA

Before Rita

After Rita

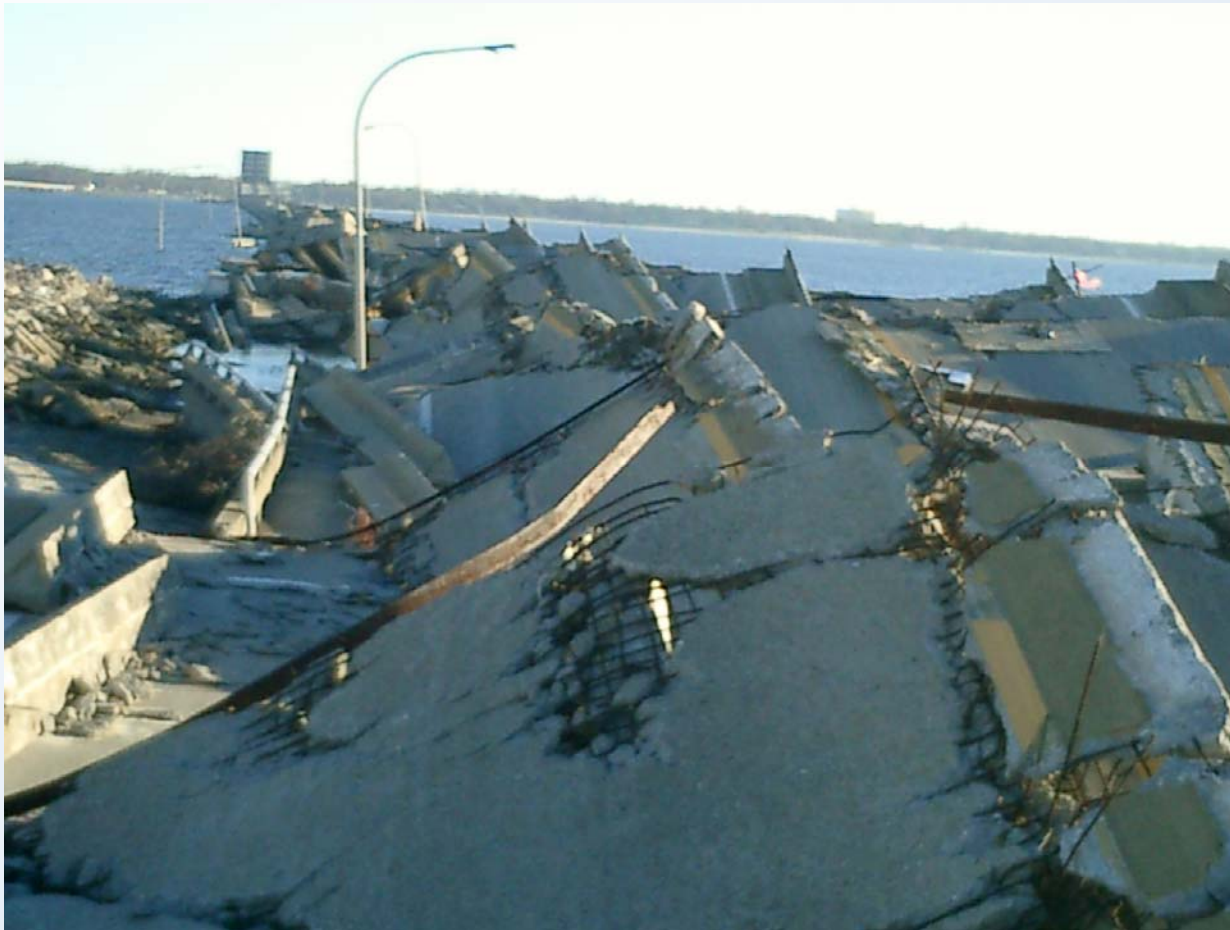
# U.S. Highway 90 Bridge at Biloxi

- Failure due to storm surge.
